# HUMAN FACTORS ANALYSES OF A FALL AND DROWNING IN A RIVER AT FALLS PARK, SIOUX FALLS, SOUTH DAKOTA

Jayne v City of Sioux Falls

United States District Court, District of South Dakota, Southern Division, Case No. 18-4088

Kenneth Nemire, Ph.D., CPE HFE Consulting LLC P. O. Box 111874 Campbell, CA 95011 June 29, 2019

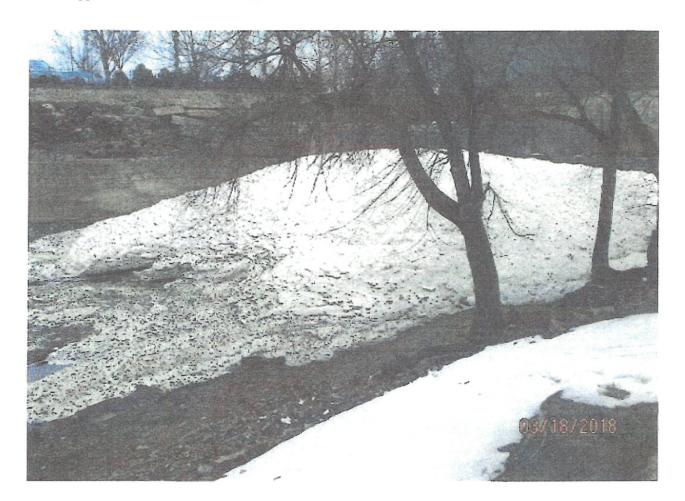
**EXHIBIT K.** Photograph taken by City a few hours after Maggie's fall. Note jagged, rocky, canyon wall on other side of river, and that the foam is primarily over the river. Also note that what appears to be snow in the foreground is a different color and texture from the foam on the river.

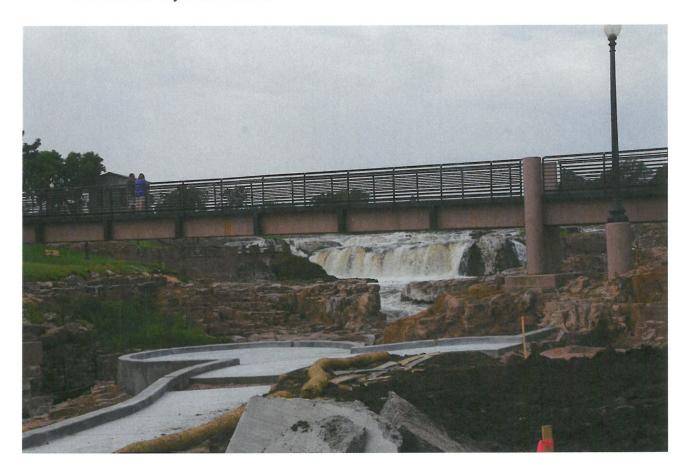
**EXHIBIT L.** View of falls and river from location Ms. Jayne and Ms. Melendez were standing when Ms. Melendez took her three produced photos (K. Nemire photo #2990). Note the tall rocky walls of the canyon, and the turbulent waters of the falls and river. This area of the river was not covered in foam on the day of the incident.

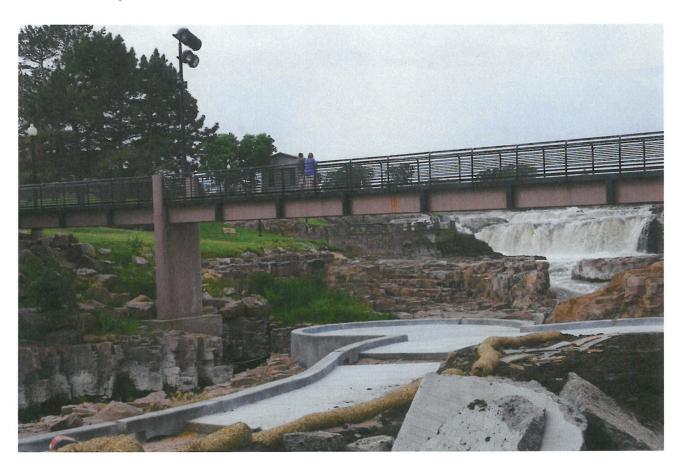
**EXHIBIT M.** View of falls and river from location Ms. Jayne and Ms. Melendez were standing when Ms. Melendez took her three produced photos (K. Nemire photo #2991). Note the tall rocky walls of the canyon, the jagged line of the canyon walls, the uneven surfaces on top of the canyon walls, and the turbulent waters of the falls and river. This area of the river was not covered in foam on the day of the incident.

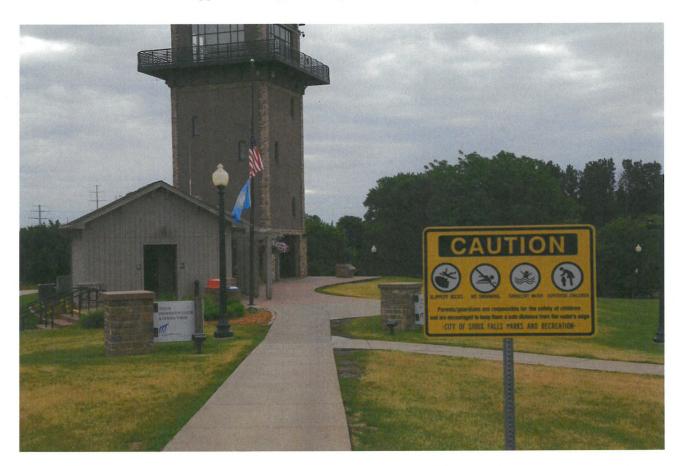
- a. Ms. Gill claimed the warning signs installed at various locations around Falls Park (Exh. Q) were inadequate because they failed to warn about the hazard of the foam (Gill p. 4). As indicated earlier, there was no need to warn about the foam because it did not constitute a hazard independently of the open and obvious subject fall and drowning hazard.

- e. Ms. Gill also implied that the subject Falls Park warning sign (Exh. Q) was inadequate because it was not designed by "trained professionals" (Gill p. 11). She also stated that the warning sign was not in accordance with the ANSI Z535 standards because the sign failed to warn of the hazards presented by the foam (Gill p. 11). As indicated in Section 8.1 and 8.2 of this report, there was no need to provide separate warnings about the foam, because the foam did not constitute a hazard. The existing warning sign, while apparently not designed by hazard communication experts, was comprised of the elements of an effective warning sign. The individual features of the existing warning sign will be discussed below:

**EXHIBIT Q.** Warning sign located along the sidewalk connecting the parking lot and the observation tower entrance (K. Nemire photo #2959). Note that the sign presents a prominent feature as one would approach and pass the sign. It would most likely be noticed by most visitors.

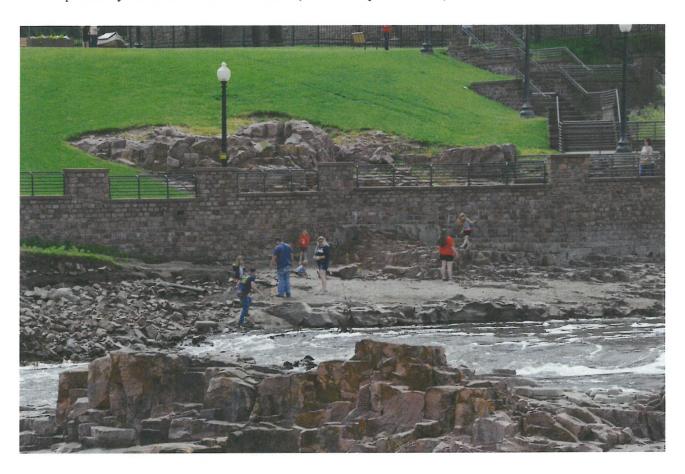
**EXHIBIT S.** Example adults maintaining close proximity to children, and children maintaining far proximity--at least 10 feet--from river (K. Nemire photo #3018).

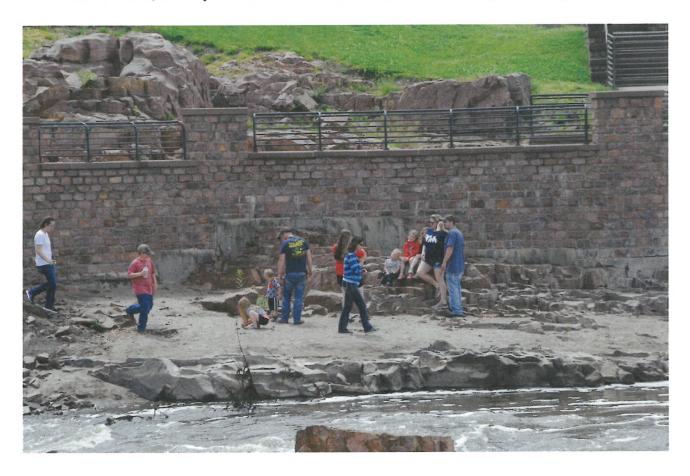
**EXHIBIT T.** Same group as shown in Exhibit S, showing that adult proximity from children and children distance from river was maintained over time. Another group entered this scene, with older children, and they also maintained a safe distance from the river (K. Nemire photo #3020).

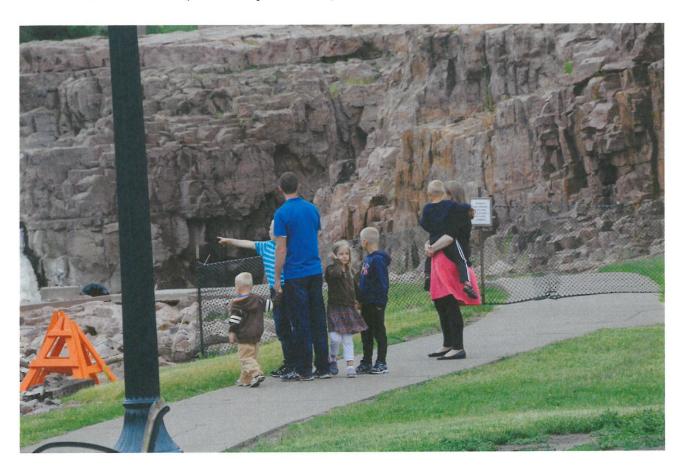
- iv. Sometimes an adult monitored the action of the younger child by holding the child's hand or carrying the child (Exh. U).
- e. Ms. Jayne did not act in a way that would be expected of parental supervision, and did not act to closely monitor her young child as did other parents observed at Falls Park. Ms. Jayne failed to maintain a close distance to her five-year-old child in an obviously hazardous environment. Consequently, Ms. Jayne failed to adequately monitor Maggie.

**EXHIBIT U.** While this group remained on the sidewalk and did not venture onto the rocks and near the river, the adults maintained proximity with the younger children by carrying one and holding the hand of another (K. Nemire photo #3067).
